Techline News

CONTENTS

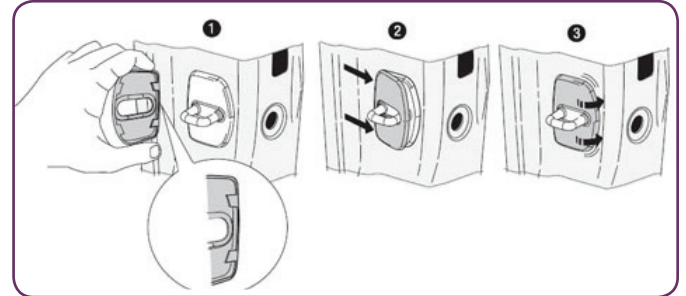
Position the rounded side of the cover toward the outboard side of the vehicle.

When installing the door striker, check its orientation to ensure it is not installed backwards. The rounded side of the cover should be positioned toward the outboard side of the vehicle during installation.

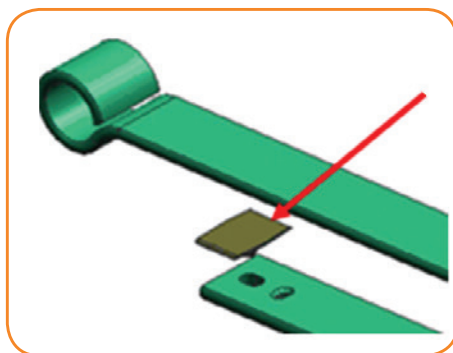
A squeak noise from the rear leaf springs on 2015 Colorado and Canyon; 2007-2015 Silverado and Sierra; 2007-2012 Colorado and Canyon; 2007-2010 Hummer H3 and H3T; and 1999-2007 Silverado (Classic) and Sierra (Classic) may be due to debris getting between the leaf springs. The frequency and severity of the noise is affected by the types of local roads on which the vehicle is driven.

Apply grease on the front and rear tip inserts.

Pressure wash the rear leaf springs to remove as much dirt and debris as possible. Dry the springs with compressed air. Apply a liberal amount of grease (P/N 12345996, U.S.; P/N 10953501, Canada) both underneath and on top of the front and rear plastic pad inserts for the #2 and #3 leaves. Protect any tool used to gently pry up the tip inserts to prevent damage to the spring leaves. Refer to Bulletin #06-03-09-004G for more details.

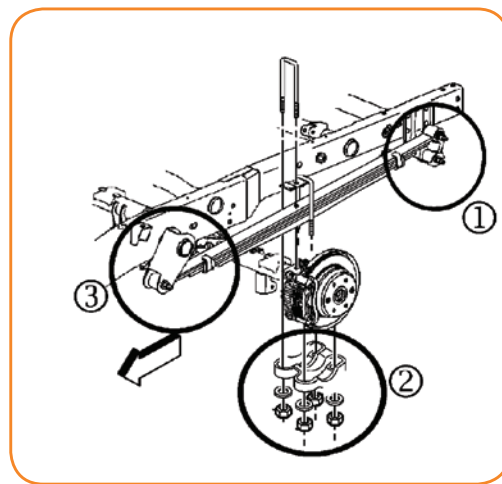
Clunking noises on 2015 Colorado and Canyon; 2014-2015 Silverado 1500, Silverado 2500/3500, Sierra 1500, Sierra 2500/3500; and 2007-2013 Silverado and Sierra models can usually be eliminated by re-torquing the joints of the leaf spring assembly. This includes the shackle joint to the frame and to the rear eye (Fig. #1), the anchor plate U-bolts (Fig. #2), and the front rear-spring mounting nut. (Fig. #3) Refer to the appropriate Service Information for the correct torque specifications. Refer to Bulletin #09-03-09-001C for additional information.

Re-torque the joints of the leaf spring assembly.

TIP: It is not necessary to remove the fuel tank to re-torque the leaf spring.

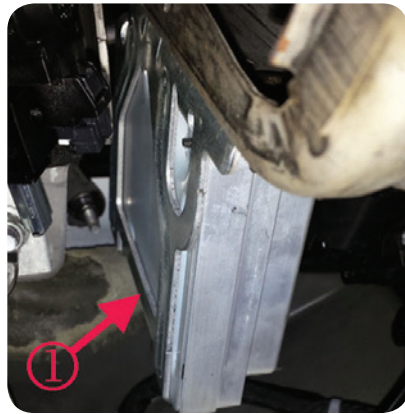
Accessory power control module

Condition 1: A metallic rattle-type sound from the left side of the instrument panel area.

The sound may be caused by the K14 110 volt power inverter module not being seated properly in the mounting bracket. Inspect the accessory AC and DC power control module located to the right of the steering column for possible movement against the mounting bracket.

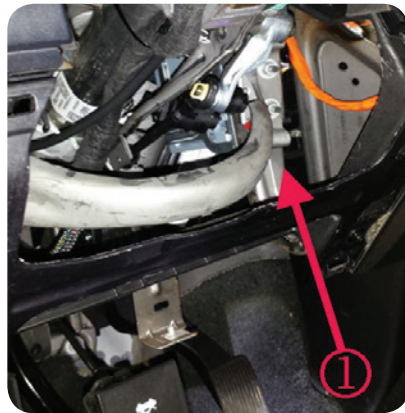
The accessory power control module is located to the right of the steering column.

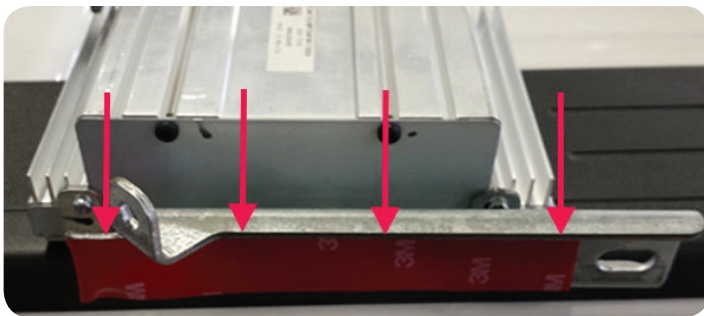
Apply two-sided tape to the module bracket.

Also remove the K14 power inverter module and apply Kent Automotive two-sided tape (P/N P40519) or equivalent to the module bracket to insulate it from the mount.

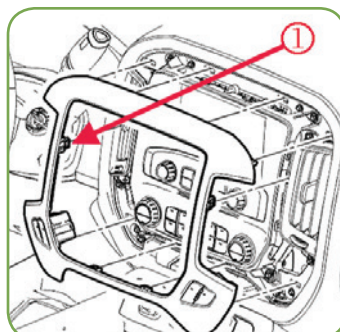
Condition 2: A rattle or itch-type sound from the center of the instrument panel in the radio area.

The instrument panel accessory bezel may be rattling due to insufficient tension of the retainers. Press on the bezel while duplicating the sound to see if it is eliminated. Wrap Kent Automotive BRS flocking tape (P/N KT13487) or equivalent over the ten retainers and reinstall the bezel.

Apply flocking tape over the retainers.

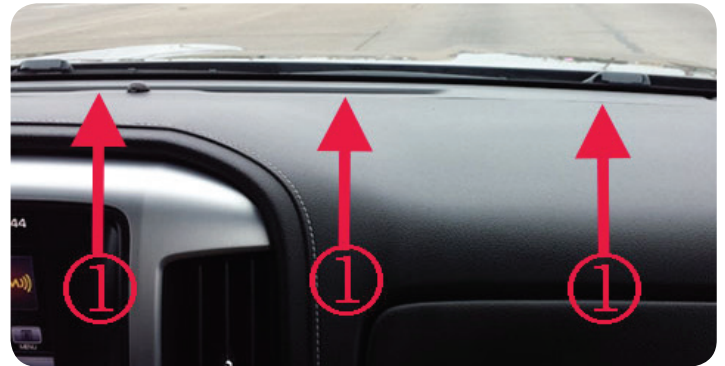
Defroster grille

Condition 3: A rattle or itch-type sound from the instrument panel area near the windshield.

The defroster grill may be rattling due to insufficient retention of the retainers. Press on the defroster grille while duplicating the sound to see if it is eliminated.

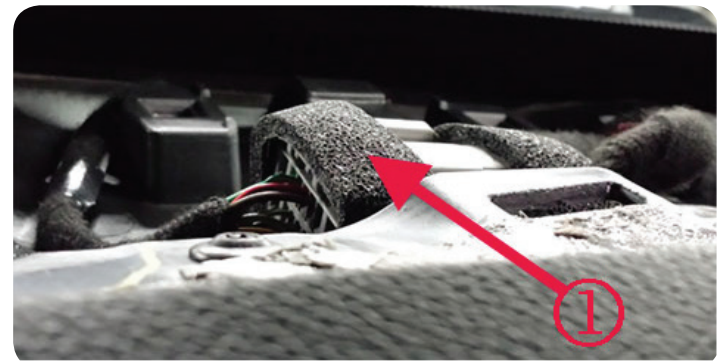
Apply foam tape around the connectors.

Remove the defroster grille and apply foam tape around the connectors located under the grille to prevent them from rattling on the grille.

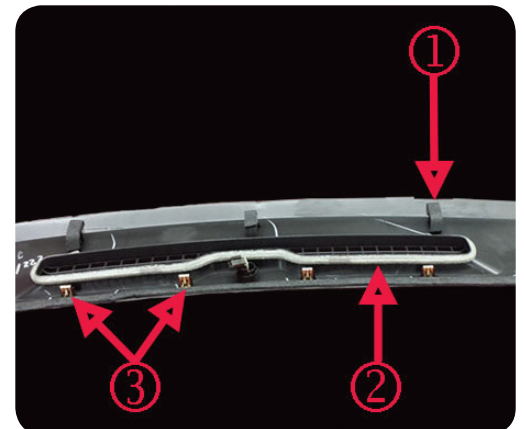
Apply foam tape to the mounting hooks (#1) and along the grille (#2) and wrap flocking tape over the retaining tabs (#3).

Also wrap Kent Automotive BRS flocking tape (P/N KT13487) or equivalent over the 22 metal retaining tabs that secure defroster grill in position. (Fig., #3)

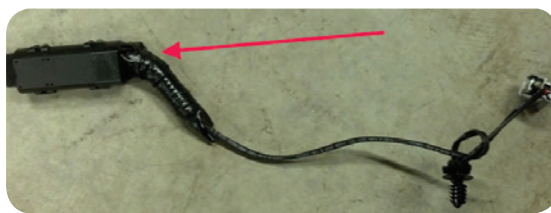
Driver's cushion haptic seat motor

This condition may be caused by an open Driver's Cushion Haptic Seat Motor circuit or high resistance near the motor.

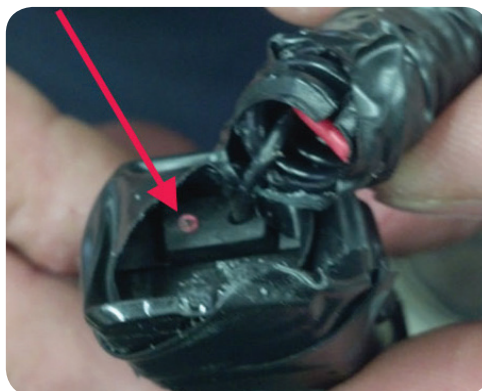
Open haptic seat motor circuit

TIP: The haptic seat motor has a pigtail lead coming off the motor. In many cases, the wiring pigtail near the haptic seat motor may be broken. Do not repair the pigtail wiring; replace the haptic seat motor.

Using a scan tool, go to the Seat Memory Control Module and command on the left and right driver's cushion haptic seat motors. If a haptic seat motor does not operate, follow the appropriate Service Information and perform further diagnosis.
